Case History

Balancing an over fire air fan (OFA)

by John Kingham

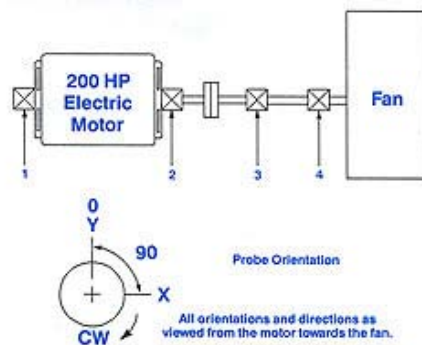
Figure 1
Machinery arrangement diagram

particular. This unit was a 200 HP fan of overhung, squirrel cage design utilizing rolling element bearings for rotor support (Figure 1).
